## Erosion Control and Trail Condition Improvements at Chimney Rocks Park in Blair County

**Team: Chimney Rock ‘n’ Roll**

April 29, 2019

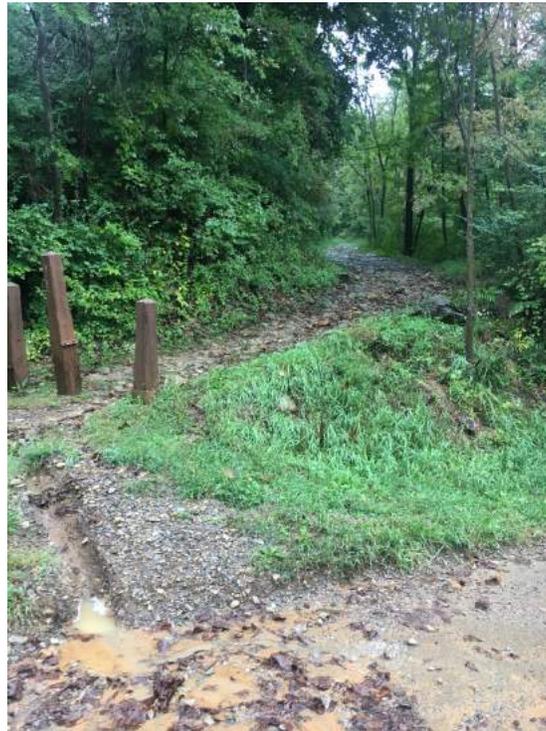
Figure 2.1. Erosion and gully forming at the trailhead

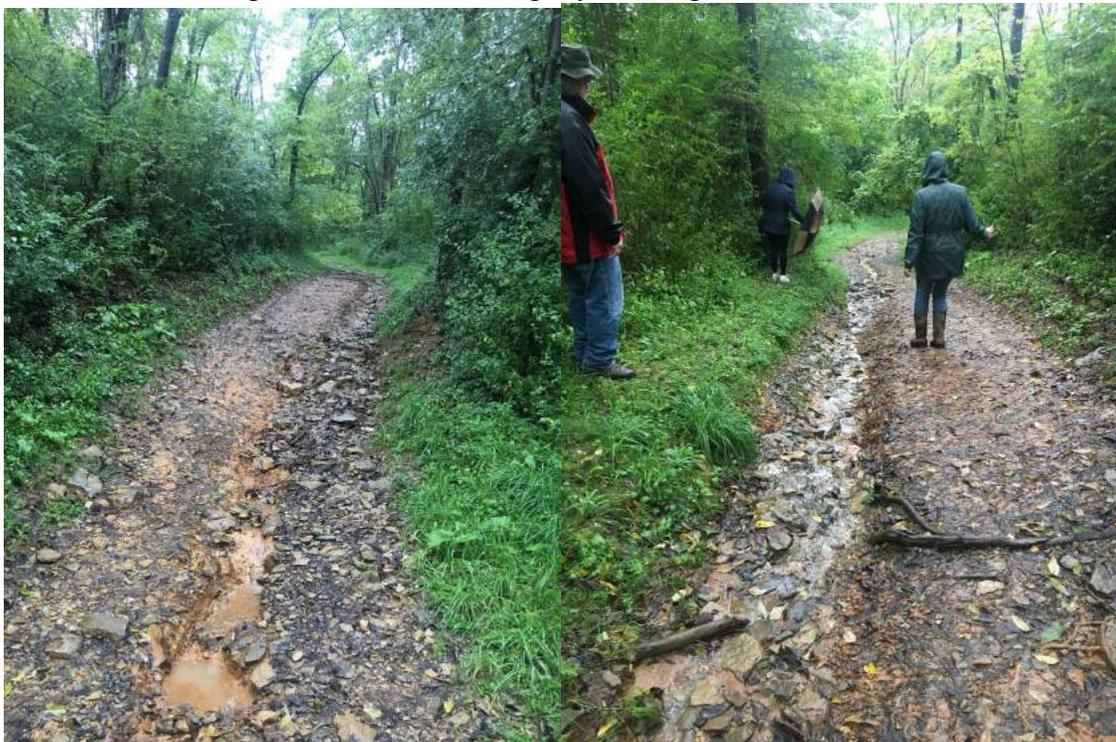
Figure 2.2. Major erosion at the start of the trail. On the left is looking up the trail. On the right is the same location in the trail but looking down the slope.

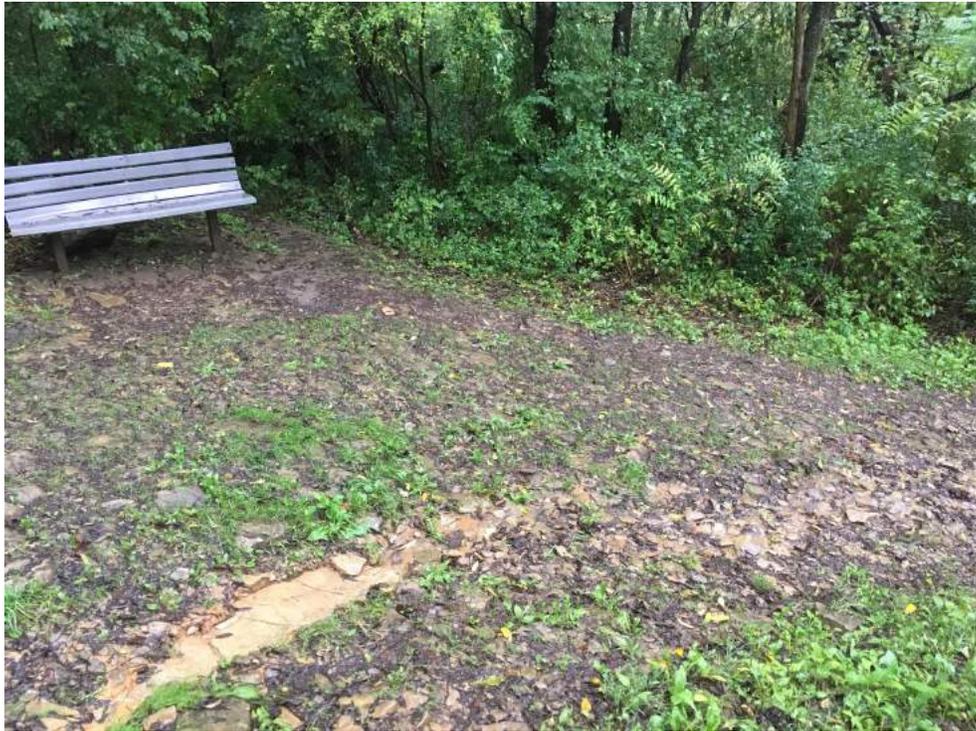
Figure 2.3. Erosion near the bench at the switchback on the trail

At location 5, the concepts of a waterbar, broad-based dip, and grade break were considered (table 5.7). This is located at the point in the trail where there is a bench and the trail takes a sharp turn to the left. At this location the waterbar concept scored the highest. This is because this location is relatively flat and a waterbar would be the only concept that would be effectively implemented and effectively control the stormwater. The volume of water that needs to be controlled at this location after a 25-year 4.61 inch precipitation event was found to be 3474 ft<sup>3</sup> and the peak flow rate was determined to be 0.72 cfs. A waterbar would be able to be designed properly to convey this amount of runoff volume.

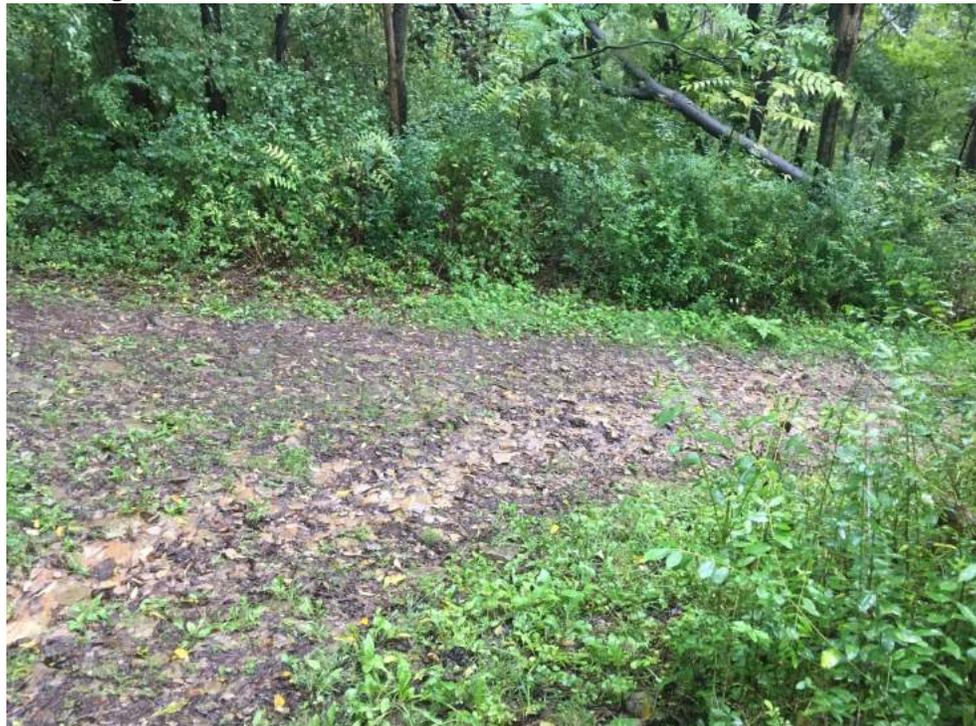
Figure 2.4. Lower erosion after the switch back

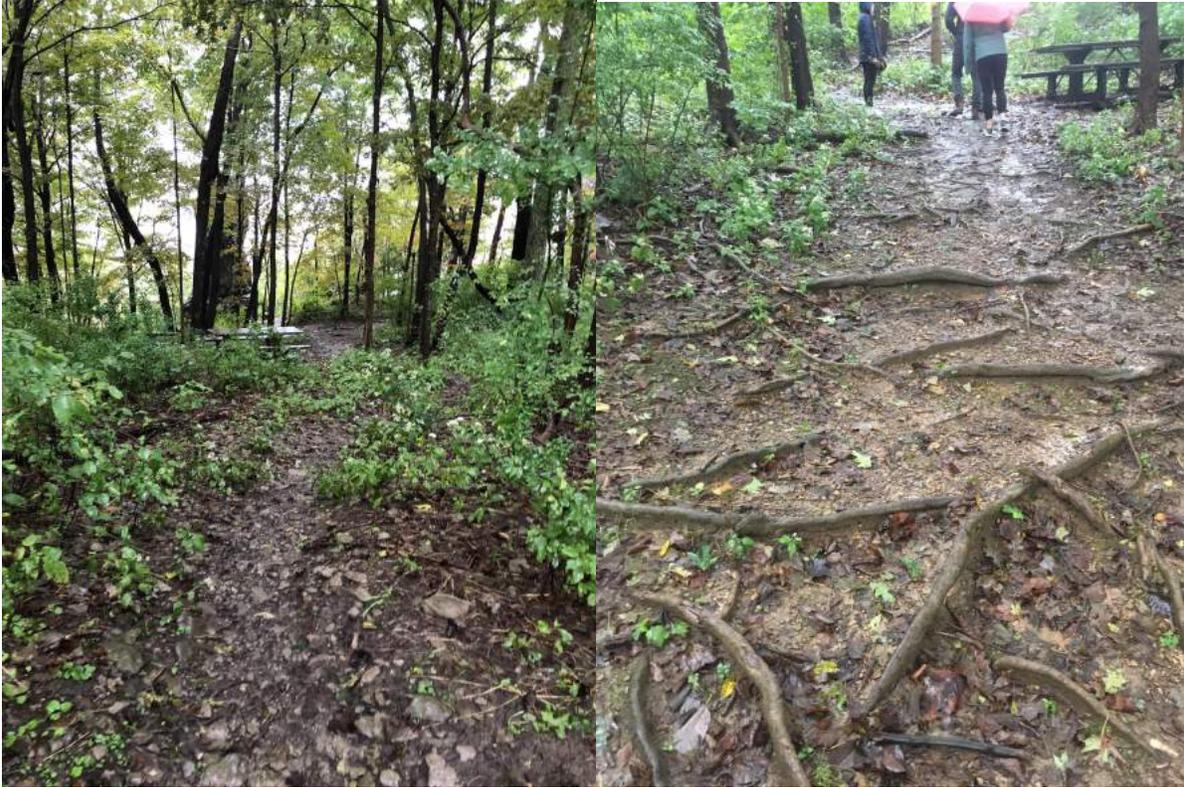
Figure 2.5. Side trail to the chimney rocks. Looking down the trail (left). Looking up the trail where roots hold the trail in place (right).

At location 7, the concepts of a waterbar, broad-based dip, and grade break were considered (table 5.9). This location is on the side trail that leads to the chimney rock formations. The trail at this location is relatively steep which could reduce the effectiveness of a waterbar and caused this structure to score as second. The orientation of the trail caused the grade break to score the lowest. At this location the broad-based dip was determined to be the best concept to implement. The volume of water that needs to be controlled at this location after a 25-year 4.61 inch precipitation event was found to be 1717 ft<sup>3</sup> and the peak flow rate was determined to be 0.42 cfs. A broad-based dip would be able to be designed properly to convey this amount of runoff volume.

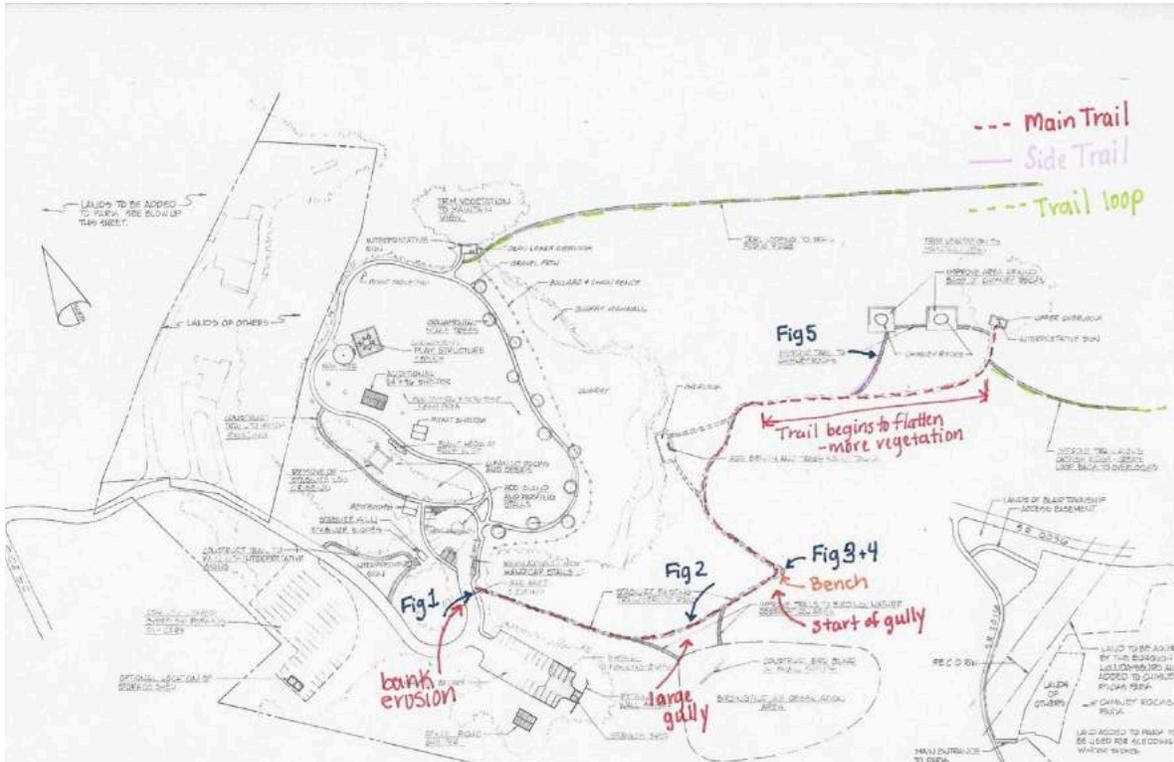
Figure 2.6. Map of trail system and conditions on the trail
